Manhole Inspection Summary

Manhole # S15C1_004MH

Insp Date: **5/27/08 10:50 AM**

Location Address: **2930 inverness av**

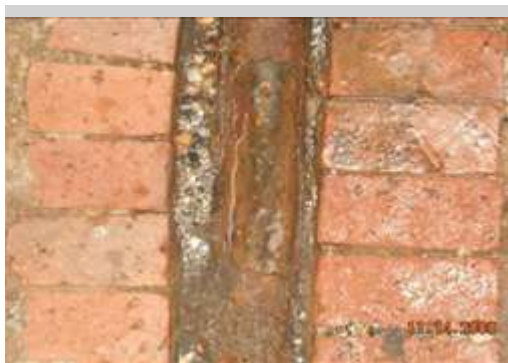
OPENNING IN PIPE/CHANNEL

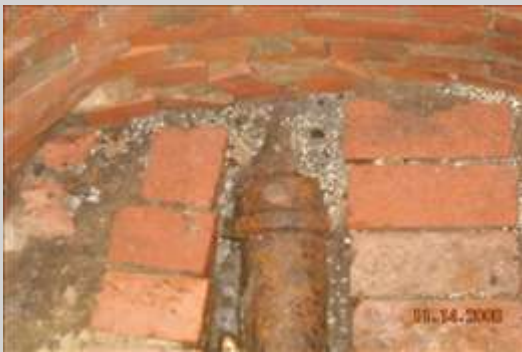
12 O'Clock Outflow

Comments **4" DUCTAL IRON PIPE NOT CONNECTING TO ANY KNOWN MANHOLE**

4 in. Circular Gravity Sewer
Pipe Out @ 12 O'Clock

Pipe Height: **4.8** (in.) Rod and Bar (Angled)
Pipe Material: **DIP/CI** ☐ Pipe Lined
Invert Depth: **6.25** (ft.) Flow Characteristics: **Slow**
Deposits: ☒ None ☐ Mud ☐ Sludge ☐ Debris ☐ Grease
Silt Depth: **0** (in.) Deposits Extent:
Infiltration: **None** Pipe Seal Cond: **Sound**

Connects To: **Connecting Node Not Available**

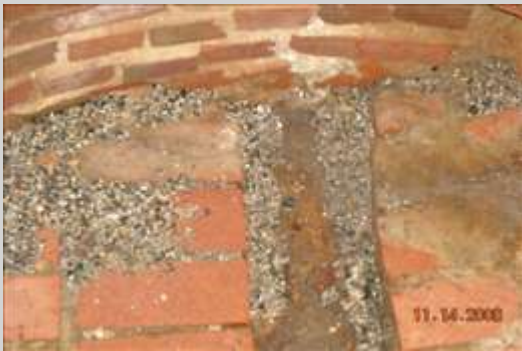
6 O'Clock Inflow

4 in. Circular Gravity Sewer
Pipe In @ 6 O'Clock

Pipe Height: **4.8** (in.) Rod and Bar (Angled)
Pipe Material: **DIP/CI** ☐ Pipe Lined
Invert Depth: **6.17** (ft.) Flow Characteristics: **Slow**
Deposits: ☒ None ☐ Mud ☐ Sludge ☐ Debris ☐ Grease
Silt Depth: **0** (in.) Deposits Extent:
Infiltration: **None** Pipe Seal Cond: **Sound**

Connects To: **House connection / Service line**
